NASA TESTING
FORT HOOD, TEXAS

REPORT OF PRODUCT TESTING
M - 113 COOLING FAN ANGLE DRIVE
FORT HOOD, TEXAS

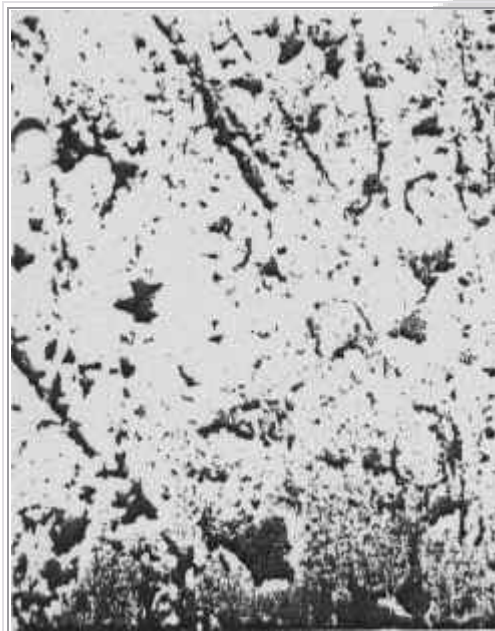
Inner Race from Treated Bearing (fig 3)

The surface coated with BOP and although the coverage is not complete, the picture shows conclusive evidence of the protection afforded the surface and that the bonding has withstood a considerable amount of extreme friction.

For all practical purposes, this surface can be considered "brand new". It becomes more dramatic when compared with the untreated surface below, and it is remembered that both surfaces were sustaining identical amounts of use.

This race is apparently capable of sustained operation and would still be serviceable.

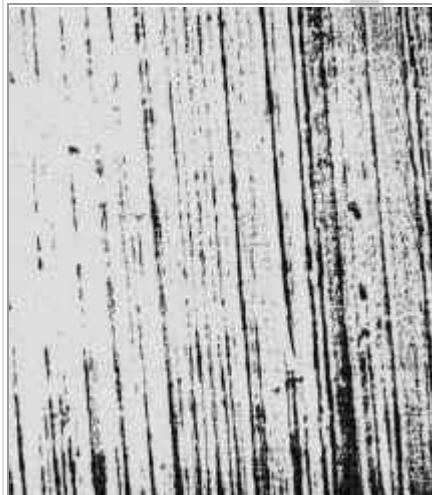
Race from Untreated Unit (fig4)

This photo shows the results of the ball in Fig. 2 skidding across the surface.

This is the classic example of galling of a race by a ball due to inadequate lubrication. Close examination shows that the metal is being "peeled" as well as scored. Pitting is also occurring.

It was this wear which allowed the impeller to develop the horizontal movement which resulted in the scoring of the inner diameter of the fan tower.

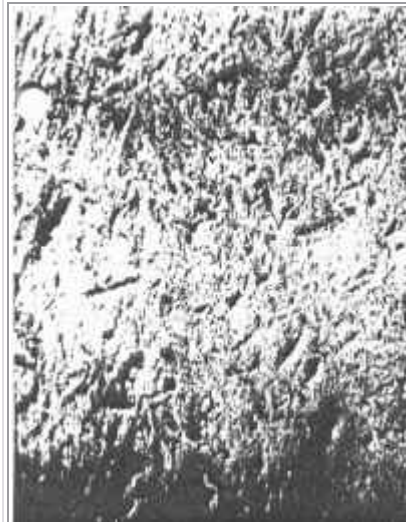
Ball Bearing from Treated Unit (fig. 1)

This surface shows signs of almost total coating with BOP and **virtually no wear or deterioration.** There is no indication of skid, smearing, brineeling, nor spalling.

This ball surface is only slightly different from a new ball.

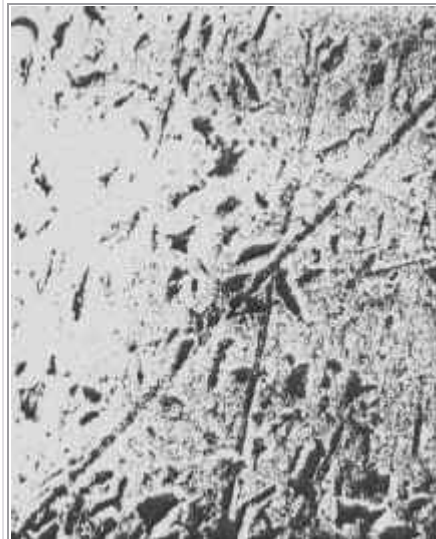
Ball Bearing for Untreated Unit (fig 2)

This ball surface shows considerable wear. There is evidence of primary brineeling, skidding and spalling.

In spite of the fact that the ball wears the least (in comparison with the race) this ball does show that it is wearing.

Wear of this nature is generally the result of inadequate lubrication. It is discussed in more detail in the evaluation of this report.

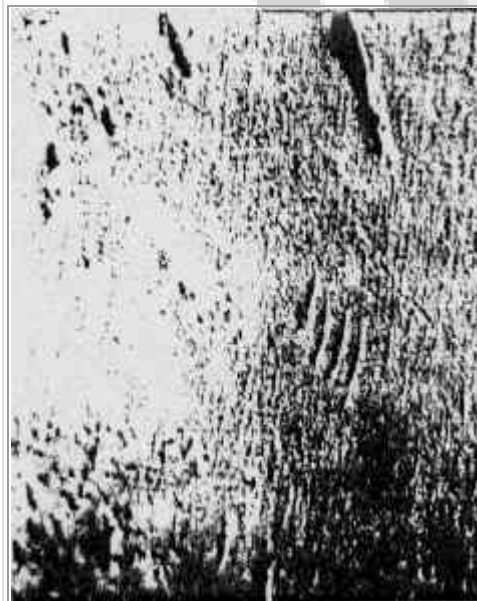
Gear in Treated Unit (fig. 5)

This gear is virtually without wear. Were it not for the coating of film it could be brand new.

The marks left by milling prove conclusively that the bonding agent does not rebond to itself. The one (1) micron thick coating has not filled the holes left by the milling process, but the coverage almost total. This dry - film lubricant was responsible for the extraordinary temperature dropping the treated unit.

The fluid lubricant has filled it's job in this unit and the dry film of BOP has reduced friction and wear
